CLIENT: John Turner Construction

SOLUTION: Bacel Hardfoam

PROJECT GOAL:

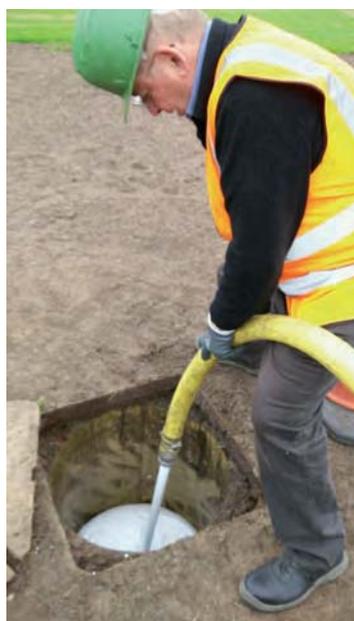
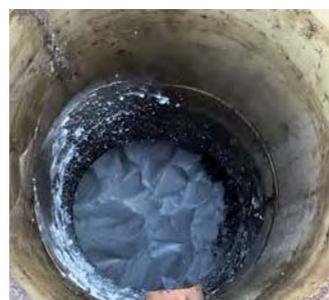
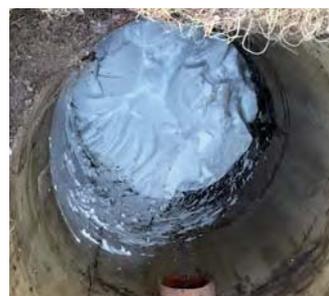
DWG arrived on site at 07.00 to be in place prior to commencement of any training and to minimise truck movement near to players cars within the car park. The tank and manhole lids were removed to gain access to the tanks and a 63mm x 4m MDPE fill pipe was placed into the base of the main tank below the filters and pumping was started, the pipe was moved from location to location within the tank until the foam had completely filled up to 1.5 meters high over the full length of the tank (8 metres long x 4m deep), after which the pipe was removed and any residual material was blown out with the aid of compressed air, the pipe was inserted into the second tank and pumping commenced until a similar level was reached.

This was repeated on both tanks lift by lift to allow the material to gel surfactant to prevent compression of the lower lifts. The foam was pumped until it was 100mm below the required finished level and the fill pipe was blown off and removed. The last 100mm was free foamed directly from the gun delivery hose to provide a stronger more liquid mix of resin this was to provide a harder finished level surface after which the client was asked to inspect the finished project and sign off as completed if happy with the job. The tank and manhole lids were replaced prior to the main contractor JTC resurfacing the area with soil and turf.
